CVEA Plant Operators Reduce Costs On Reactor Foundation Repair

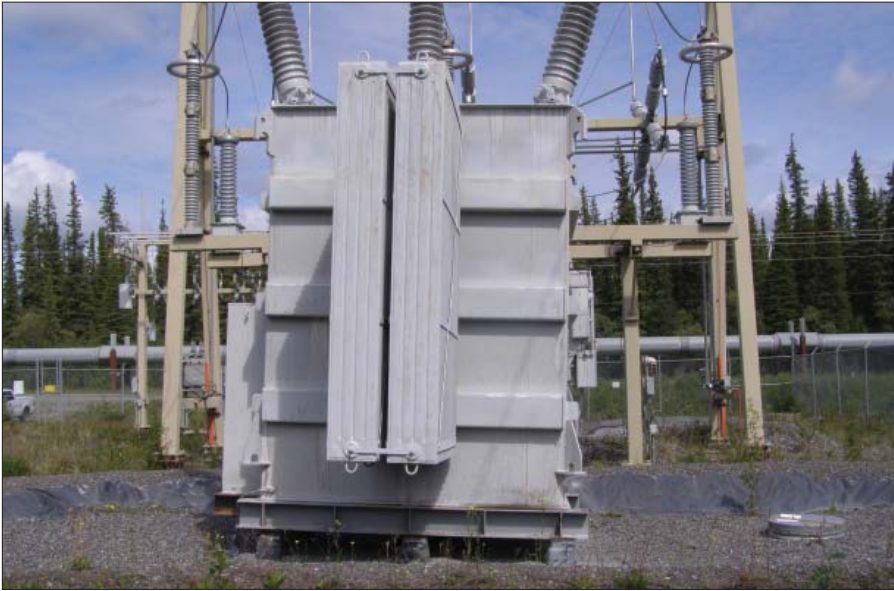
The CVEA Reactor at the Pump Station 11 Substation leaning from permafrost shifting its foundation.

The reactor sits on a foundation made of pilings in the ground. Permafrost is moving these pilings and causing a problem. The foundation has shifted, causing the reactor to lean. Leaning is bad for mechanical equipment. If the reactor leaned enough, insulating oil inside could shift exposing internal working parts and causing extensive damage like overheating, arcs and possibly even an electrical breakdown.

The plan was basically to install an adjustable, bolted connection between the top of the pilings, located underneath the reactor, and the reactor frame, allowing for spacer plates to be added that would level the reactor. This will also allow for additional spacer plates to be added or taken away from the bolted connection easily in the future, keeping the reactor level if more shifting occurs.

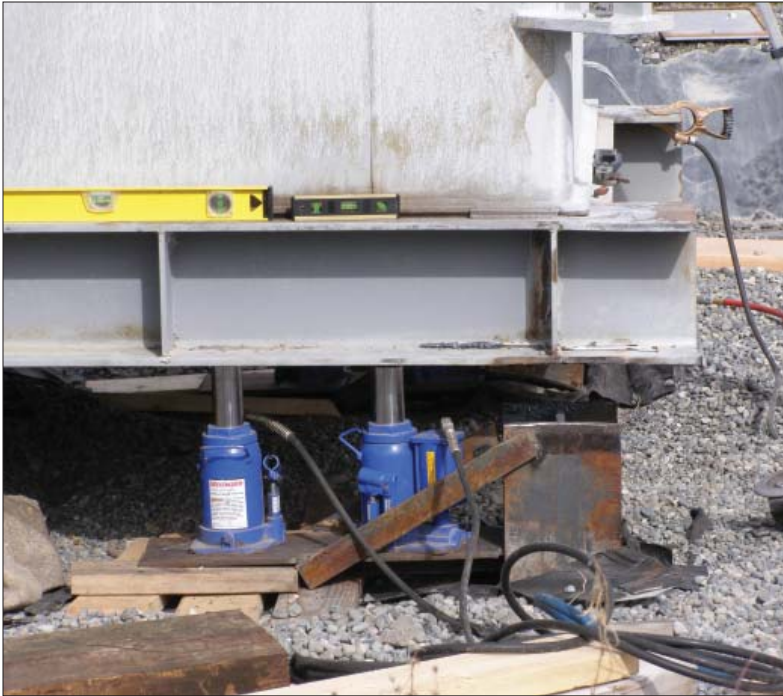
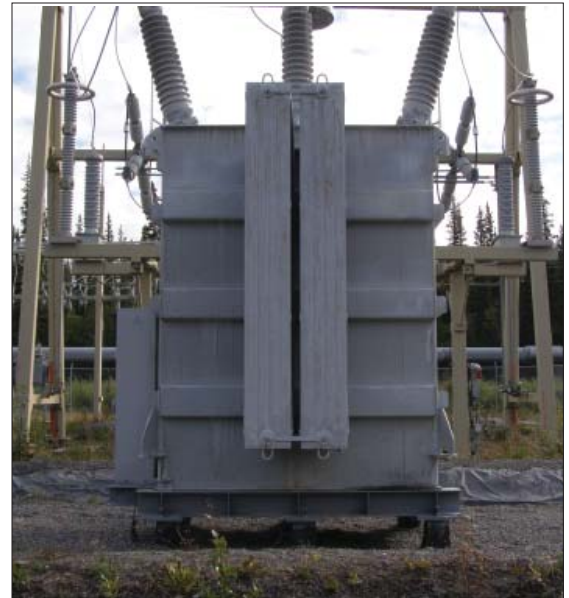
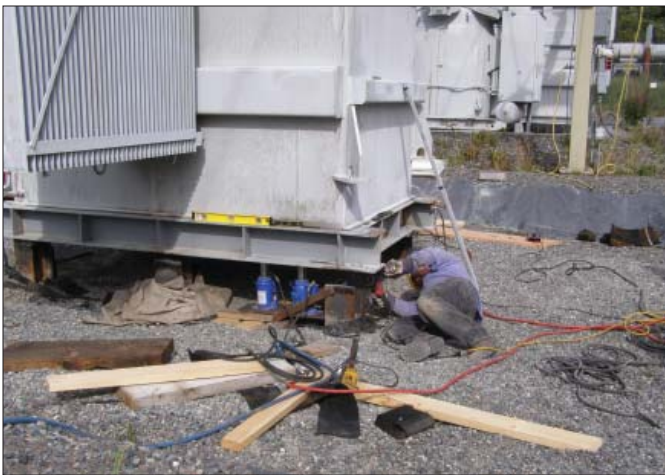
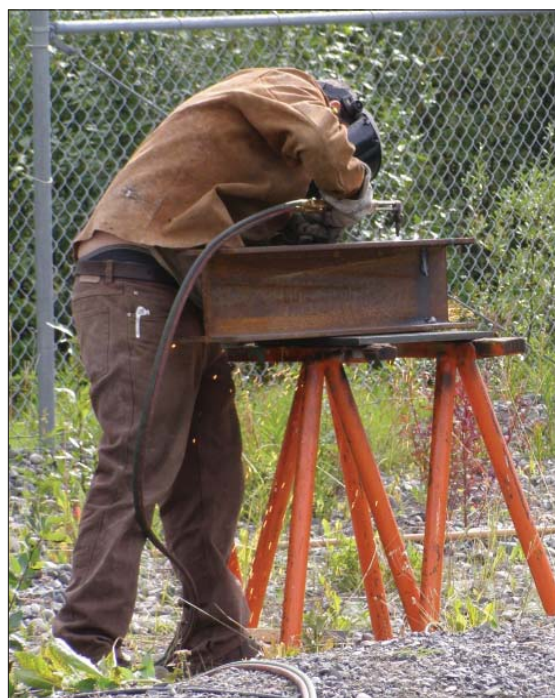
Top Left: Using heavy duty jacks to jack up the reactor. Above: Dan Dempsey, Chief Plant Operator for the diesel plants, working on the underside of the reactor. Top Right: Completed Reactor Repair Project. Bottom Right: Plant Operator, Mike Rego, welding one of the components of the structure.
Photos by Jimmy McDougald

Dan and Mike set to work on the reactor, a difficult project due to the sheer weight of the asset. Several days later, they completed the project, and by using their knowledge and skills allowed CVEA to complete the project in-house for a fraction of the budgeted amount.
