## Why Trouble Trees Cause So Much Trouble

28 JANUARY 2012 Copper Valley Electric

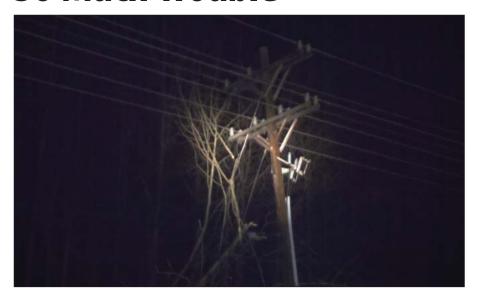
This tree on the power line in Valdez caused an outage for much of the community in November 2011.

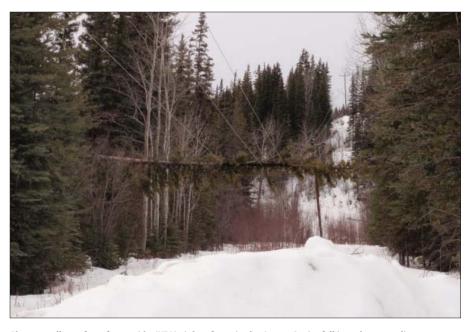
Above, a tall tree from far outside CVEA's right-of-way in the Copper Basin, fell into the power line Photo by Adam Warwas

For example, at our widest granted distribution right-of-way of 25 feet from the centerline, it would only take a 40 foot tree at the edge of the right-of-way to fall into the line and potentially cause an outage. Even if the tree was 50 feet from the centerline, it would only take a 60 foot tree falling towards the line to make contact and potentially cause an outage.
