CVEA Marker Balls What They Are & Why They're Being Replaced

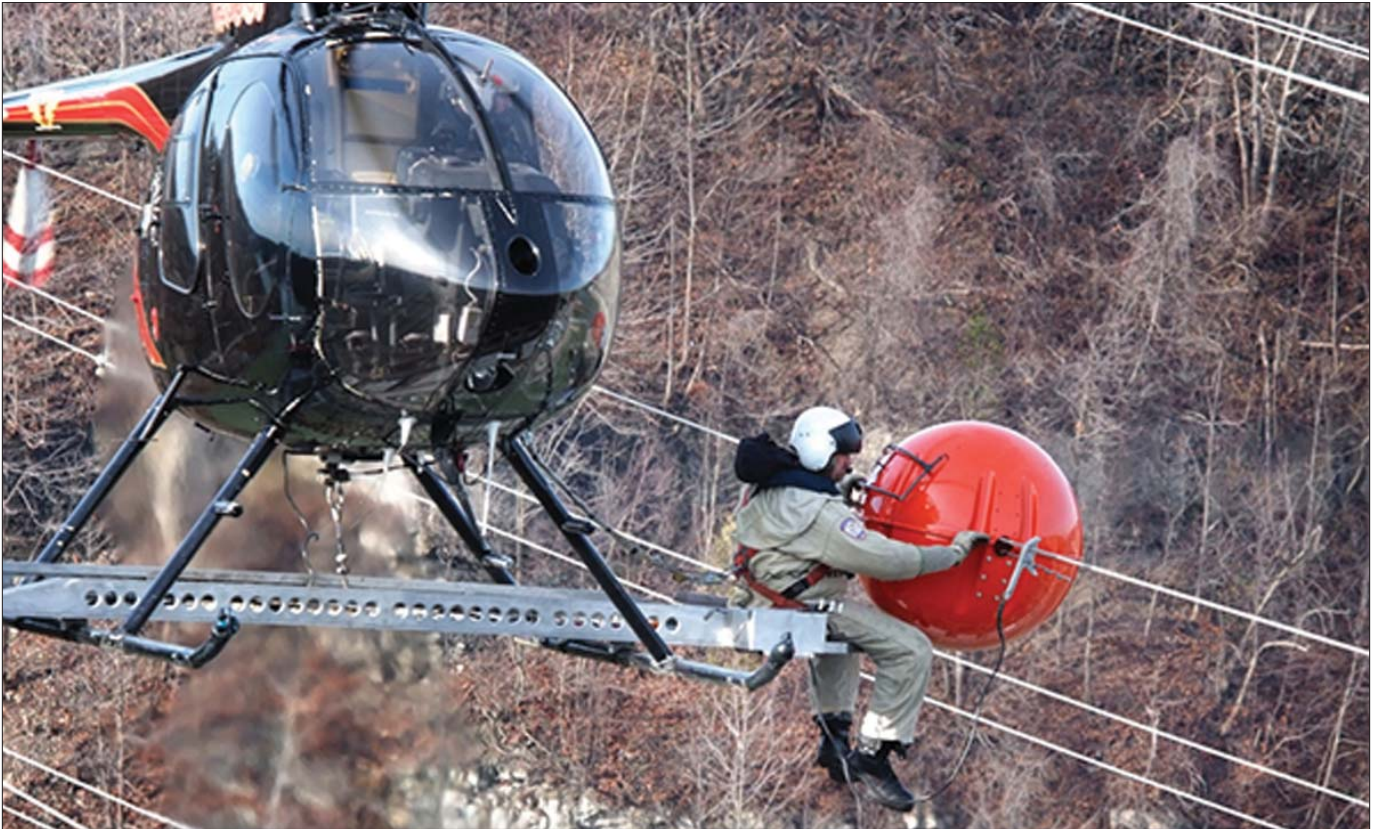
Above, a specially trained lineman performing marker ball replacement on a power line from a platform attached to a helicopter

Due to difficult terrain and accessibility issues surrounding many of the marker balls, a majority will be installed utilizing a helicopter and specialty trained linemen. These linemen will work off of a platform attached to the helicopter high in the air to remove the old marker ball and install the new one. CVEA is projecting to spend over \$1.1 million on this project, with most of this cost due to the required use of the helicopter.

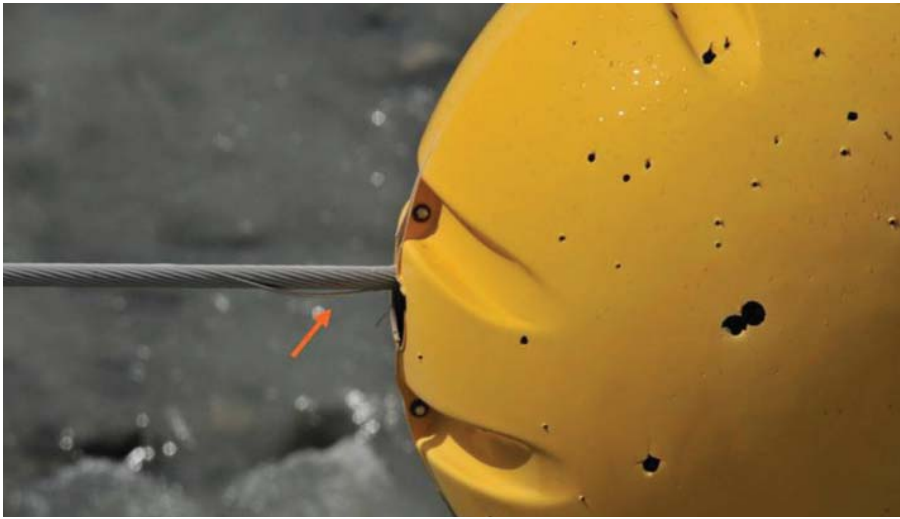
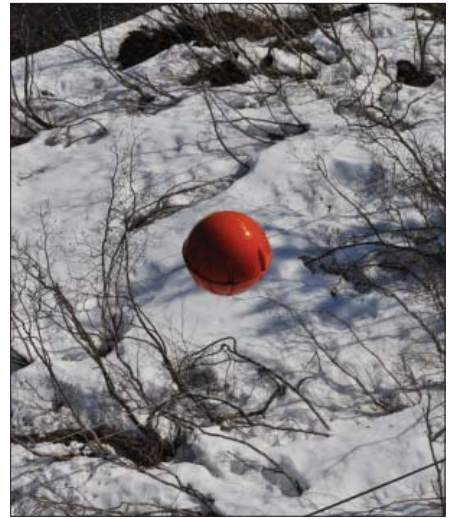
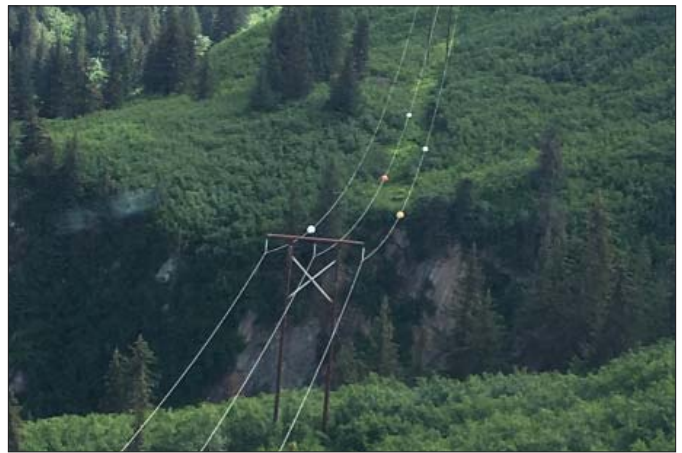
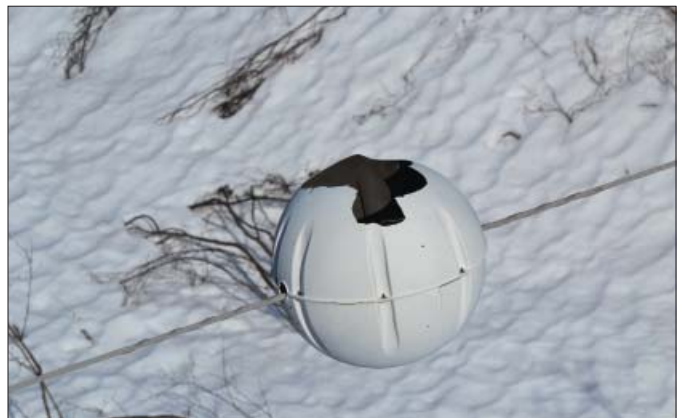
**Top left, marker ball with bullet holes and frayed wire from being hit by bullets
 Top right, a brightly colored marker ball stands out against the surrounding terrain to demonstrate the location of the line
 Middle, marker balls crossing a span of line over a gorge between structures
 Bottom, a damaged marker ball**

The average life expectancy of a marker ball is 10-15 years. This is the length of time before fading or damage causes the need for replacement. Currently, many of the marker balls along CVEA's system have faded due to ultra violet light from the sun, are damaged or parts have failed from exposure to ice and wind, or have unfortunately been used as target practice.
