CVEA Transmission Line In the Line of Fire

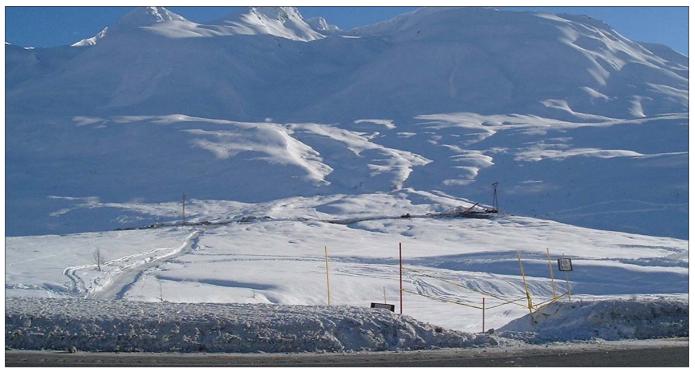
Work site after an avalanche took out Structure 46-2 in 2003.

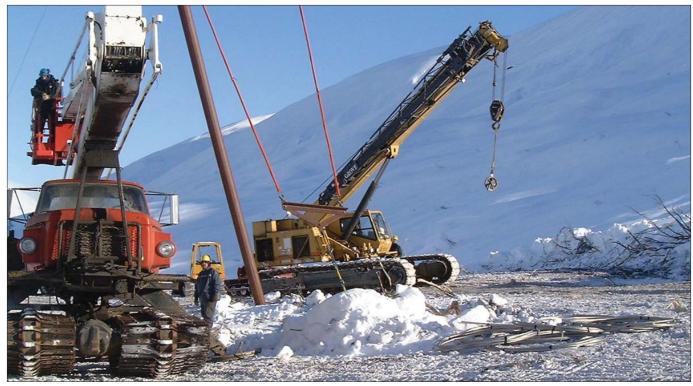
Above: City Electric work crews on site on Thompson Pass in 2003, as they worked to replace Structure 46-2 which had been taken out by an avalanche. Below: Looking Southbound down the T-Line at Structures 46-3, 46-2, and 46-1.
